Tendencies in the development of modern sacral architecture on the example of the Archdiocese of Czestochowa

Aleksandra Repelewicz¹

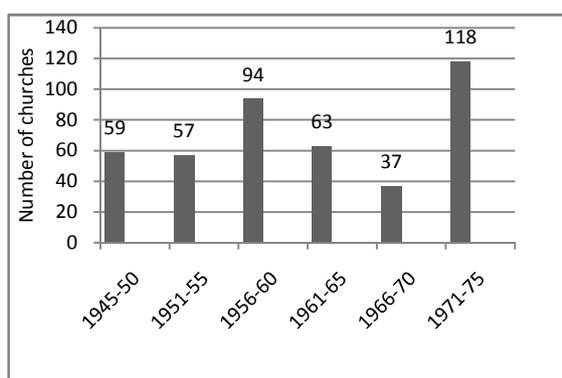
Fig. 1. Number of new churches erected during first three decades after the World War II in Poland.

There were 7555 church buildings throughout the whole country in 1945. During the first 25 years after the war, 333 sacral objects appeared (Fig. 1).

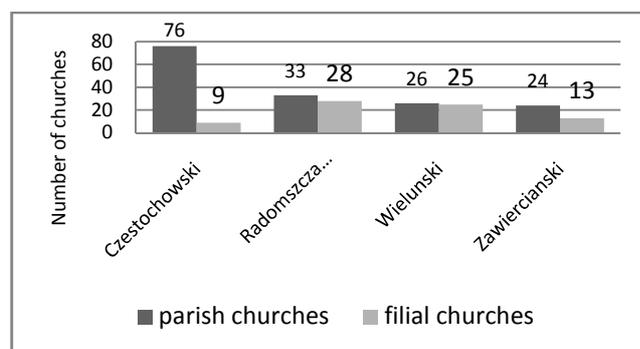
Fig. 2. Number of new churches erected in years 1945-2015 in Archdiocese of Czestochowa

When building permission was given after years of failure to receive it, the Archbishop often decided to build an inadequately huge object. The prospects of receiving further permissions were uncertain. (BIQDATA.WYBORCZA.PL; ARCHITEKTURA7DNIA.PL) The Archdiocese of Czestochowa is divided into four pastoral districts: Czestochowski, Radomszczanski, Wielunski and Zawiercianski. In the Czestochowski region of the Archdiocese of Czestochowa, 85 new church buildings have been erected since 1945 (Fig.2)

In the Wielunski region there are 51 new church buildings in total. The Radomszczanski region comprises 61 church buildings erected after World War II. The Zawiercianski pastoral region has had the least number of churches built since 1945 – 37. Generally exist 234 church buildings which were erected between 1945 and 2015.

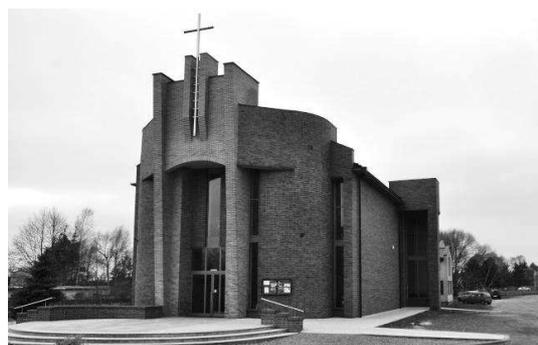
Fig. 3. Church of John Sarkander in Czestochowa
Source: autor's own photography

Examples of newly erected objects may be the following: Church of St. John Sarkander in Czestochowa (Fig. 3) is used by the community of 1320 parish inhabitants. It was built in 2002-2007. The total area of the building is 330 m². The church has a relatively small cubic

capacity. It was built with modern construction materials having good thermal insulation. It also has an interesting outside form.
