PRODUCTION ENGINEERING ARCHIVES

Influence of the environment aggressiveness on durability of girders made of S355 steel in Poland

Anna Śpiewak¹, Małgorzata Ulewicz¹, Josef Vičan²

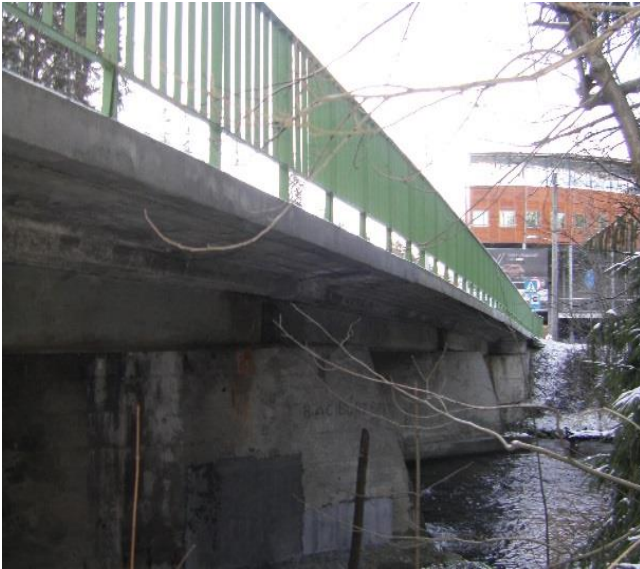
Fig 2. The analyzed bridges -stream Malinka in Wisla

For the analysis a bridge in Wisla (Fig. 1), which is part of the inter-regional road 942, and the bridge, which is part of the inter-district road 1661D in Wroclaw (Fig. 2), were chosen. The analysis was carried out based on the data from

Table 2. Data for the analyzed bridge in Wisla

BRIDGE IN WISLA – Silesian province			
Type of barrier		stream Malinka	
Road number	942	Placement	km 36+566
Durability reduction coefficient			
S_A	K_R	β	W
0.98	0.923	0.96	54
T_w	T_i	T_D	
0.98	0.90	-	
Level of shortening the time between failures of structures			S_T 0.850
Time between failures of structure due to corrosion			T_e 27

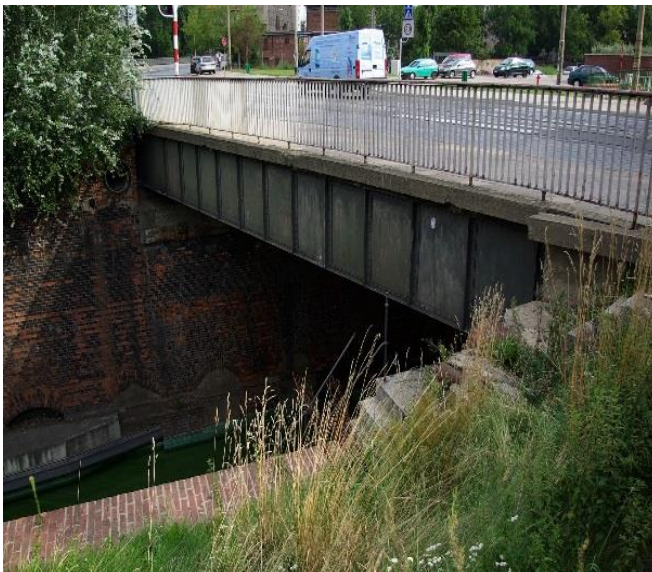
Fig 2. The analyzed bridges -lock in the city in Wroclaw

Table 3. Data for the analyzed bridge in Wroclaw

BRIDGE IN WROCLAW – Lower Silesian province			
Type of barrier		lock in the city	
Road number	1661D	Placement	Sienkiewicza Street
Durability reduction coefficient			
S_A	K_R	β	W
0.98	0.891	0.99	81
T_w	T_i	T_D	
0.99	0.96	0.96	
Level of shortening the time between failures of structures			S_T 0.847
Time between failures of structure due to corrosion			T_e 3
